UPGRADE AND INSTALLATION  
OF STORMWATER  
INFRASTRUCTURE ALONG  
DIVISIONAL RD. 1001, FROM  
KM 3.64 – KM 7.69, HANGKLIP,  
WESTERN CAPE

DEA&DP reference number: 16/3/3/1/B2/31/1009/19

ENVIRONMENTAL AUDIT QUARTERLY  
REPORT: Sept 2019 – Dec 2019

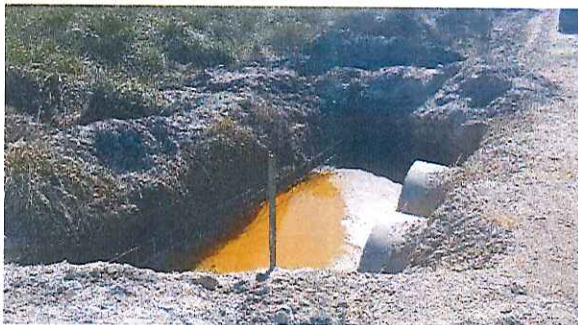
Figure 8: Culvert inlet after heavy rain - 25 October 2019

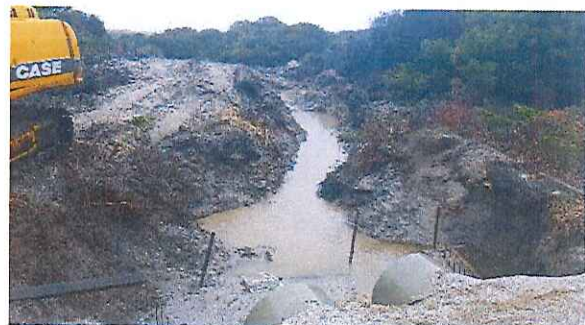
Figure 9: Culvert outlet after heavy rain – 25 October 2019

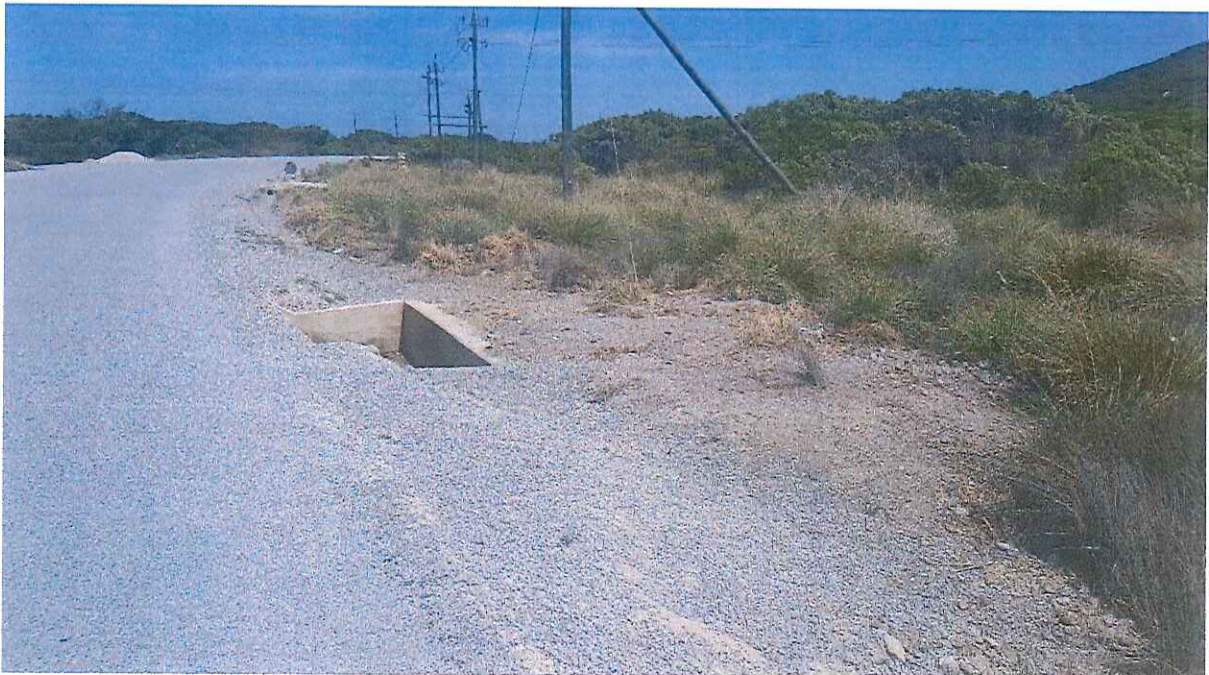
Figure 15: Pipe-culvert inlet after construction prior to rehabilitation

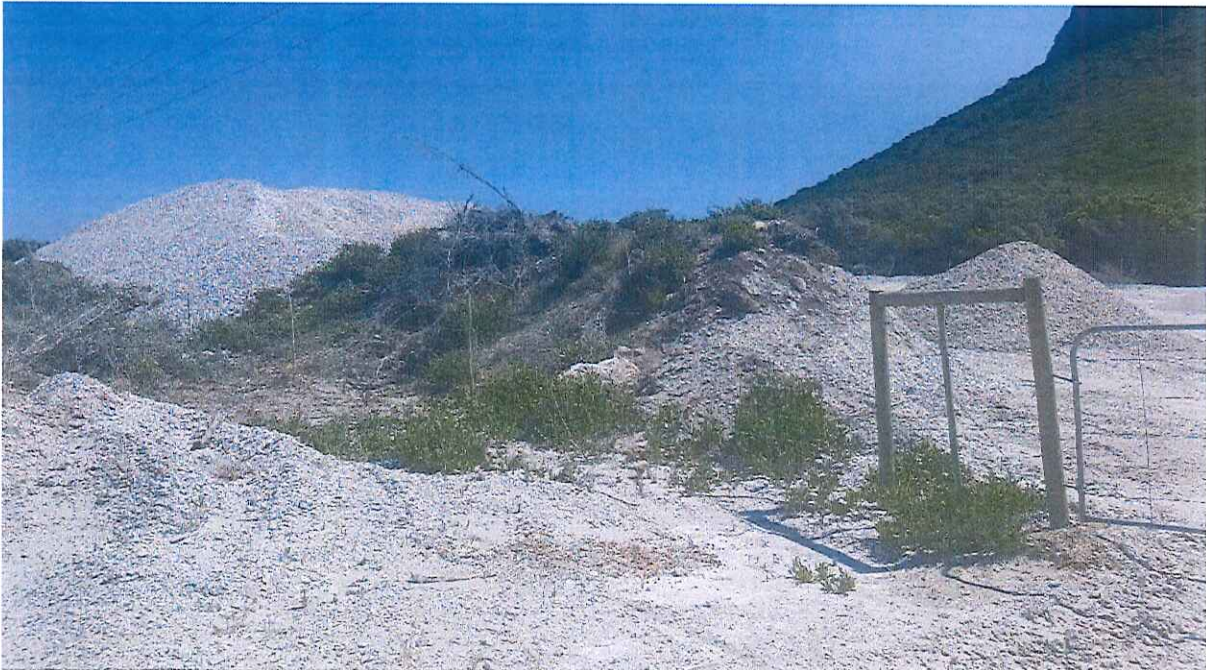
- Alien vegetation control needs to take place at the topsoil stockpile.

Figure 19: Acacia Cyclops visible on the topsoil stockpile

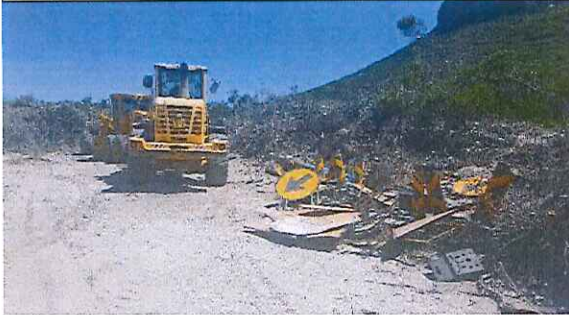
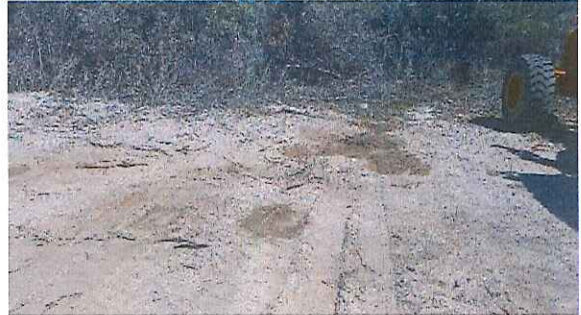
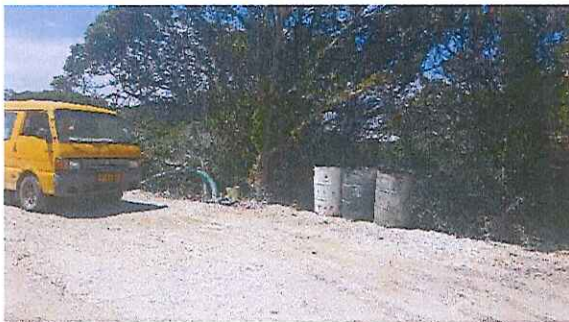
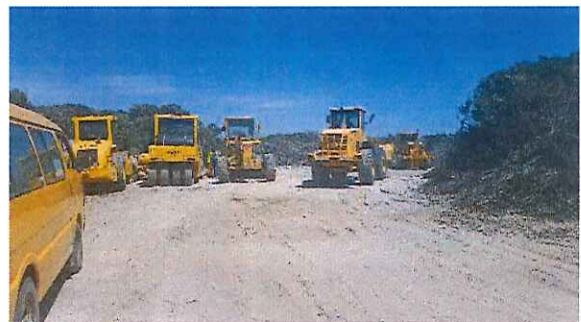
Figure 20 & 21: Construction site: Storage area for plant and equipment

- The storage area for the plant and equipment needs to be maintained. The refuse bin needs to be closed and all grease and oil spills removed. There are no drip trays on site.

Drip trays (minimum of 10cm deep) must be placed under all machinery and vehicles.	0	No drip trays were observed.
Any spills larger than 100ℓ should be reported to all local authorities.	2	No incident. Any NEMA section 30 incident will be reported to ODM and DEA&DP
Spill kits must be available on site and in all vehicles that transport hydrocarbons for dispensing to other vehicles on the construction site.	2	Kits are available for the two vehicles transporting hydrocarbons.
All spilled hazardous substances must be contained in impermeable containers for removal to a General & Hazardous Waste Landfill site, (this includes contaminated soils, and drenched spill kit material).	2	Compliant
<b>Construction: Cement</b>		
Cement must be mixed and transported in leak and splash proof containers.	2	Compliant
Should a cement spill occur, then the spilled material, as with all waste materials, must be removed completely and spoiled in a designated spoils site.	2	Compliant

Two refuse bins with lids must be provided and cleaned on a daily basis.	1	Partial compliance: Two bins on site. No lids.
Designated areas for smoking must be provided.	0	Not practical. Because construction activities take place on several locations along a linear development, a designated smoke area cannot be determined.
No fires will be allowed on site.	2	Compliant
No animals, domestic or otherwise are allowed on the premises.	2	Compliant
Litter (even if originating outside the camp) and concrete bags etc. must be picked up and put into suitably closed bins.	2	Litter originating from construction or personnel activities is collected and taken away daily to a registered transfer station.
<b>Construction: Toilets and ablation facilities</b>		
The contractor will be responsible for providing all sanitary arrangements for his and the sub-contractors team.	2	There is a toilet facility on site.
All toilets will be located within the contractor's camp.	2	The toilet is situated in the area where the plant equipment is stored.

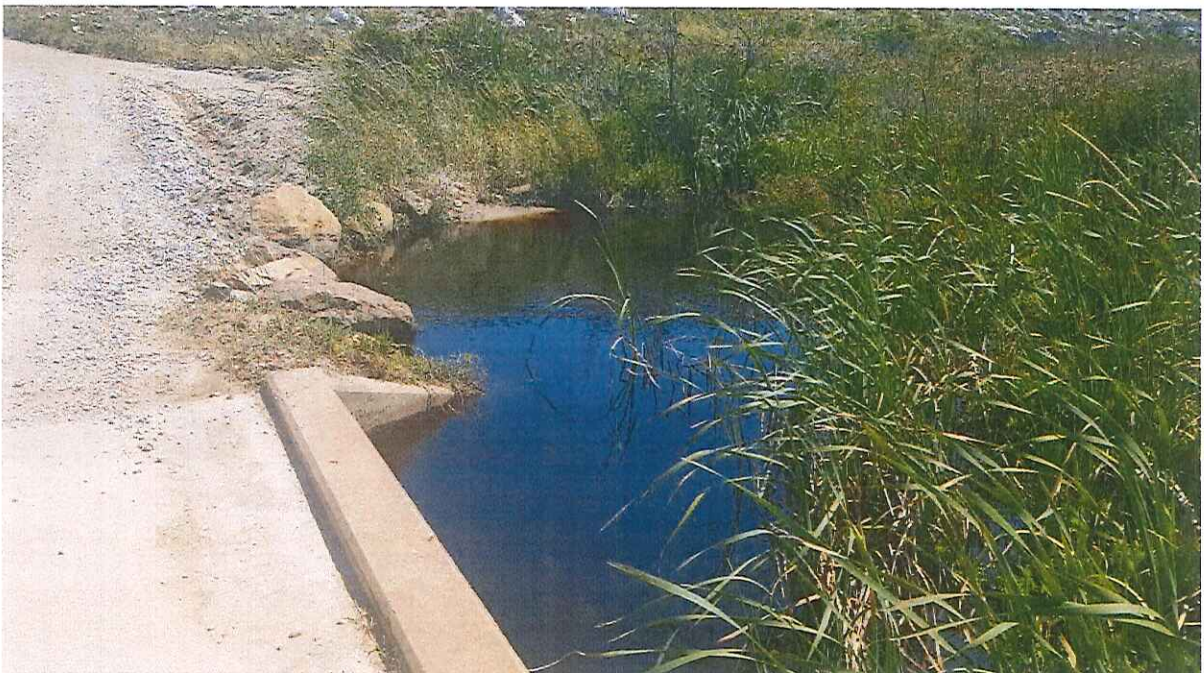
Figure 24: Water abstraction point

- Water abstraction is currently taking place at a point in the Buffels Rivier. This point has historically been used by the DPWT when doing maintenance on the gravel road. Alternative water sources are currently being investigated. The abstraction point is also monitored on a weekly basis to determine the impact. The water level at the site remains constant during the dry season.
